IC-730 2ND IF FILTER FAILURE

Bill Leahy, K0ZL/April 12, 2005

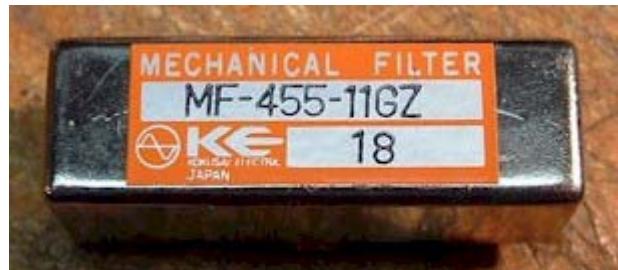
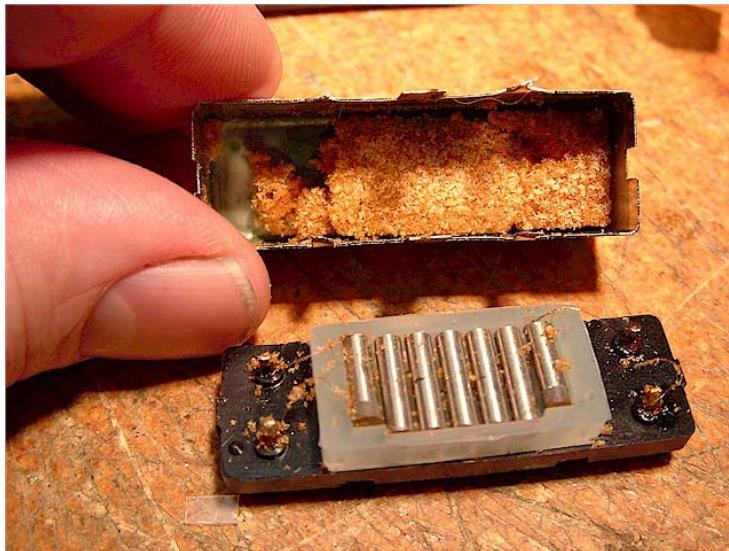
I traced the problem to a bad 2nd IF mechanical filter. The filter has KE on it as the manufacturer, and the model number MF-455-11GZ.

Upon dismantling the filter, I found a row of 7 small cylinders, lined up parallel to each other, comprising the mechanical filter elements. The wires connecting the input and output elements or transducers to the I/O pins are very fine. One set had corroded off of one of the transducers at one end. There was also some foam-looking stuff that had degraded over the years and was falling apart. Evidently the foam was to hold the little resonator and transducer elements in place in a plastic form but the ensuing degradation of the foam left the filter elements with no vertical support. The end result was a failure, probably due to being bumped in shipment. It would not have taken much for this to occur; the radio itself was very well packed upon receipt.

I had a smaller, crystal filter of the correct bandwidth to put in place of the bad filter; it was a CFJ455K5 which is inexpensive compared to the Icom/Collins mechanical filters that are available.
